**US Army Corps
of Engineers**

**Shinnecock Inlet, New York,
Site Investigation**

**Report 1
Morphology and Historical Behavior**

by Andrew Morang

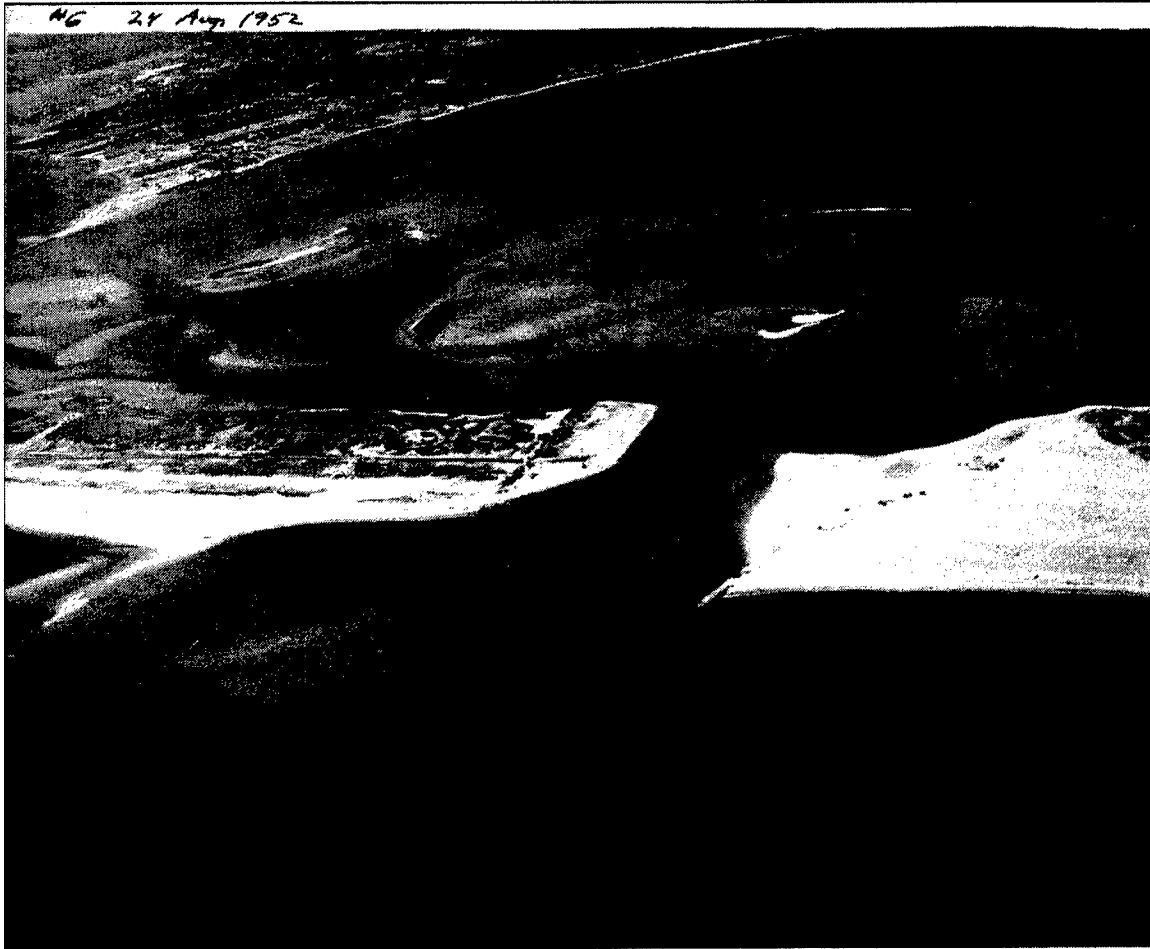
Figure 10. Photograph taken during construction of east jetty, 24 August 1952 (Channel runs northeast-southwest, closely following revetment on west shoreline and heads out to sea just east of a spit on Tiana Beach. Ebb shoal has an almost straight seaward margin. On flood shoal, three channels merge at bay end of inlet. Two of these channels, east and central, have shoaled) (Westhampton Photo Studio, from Suffolk County Department of Public Works)

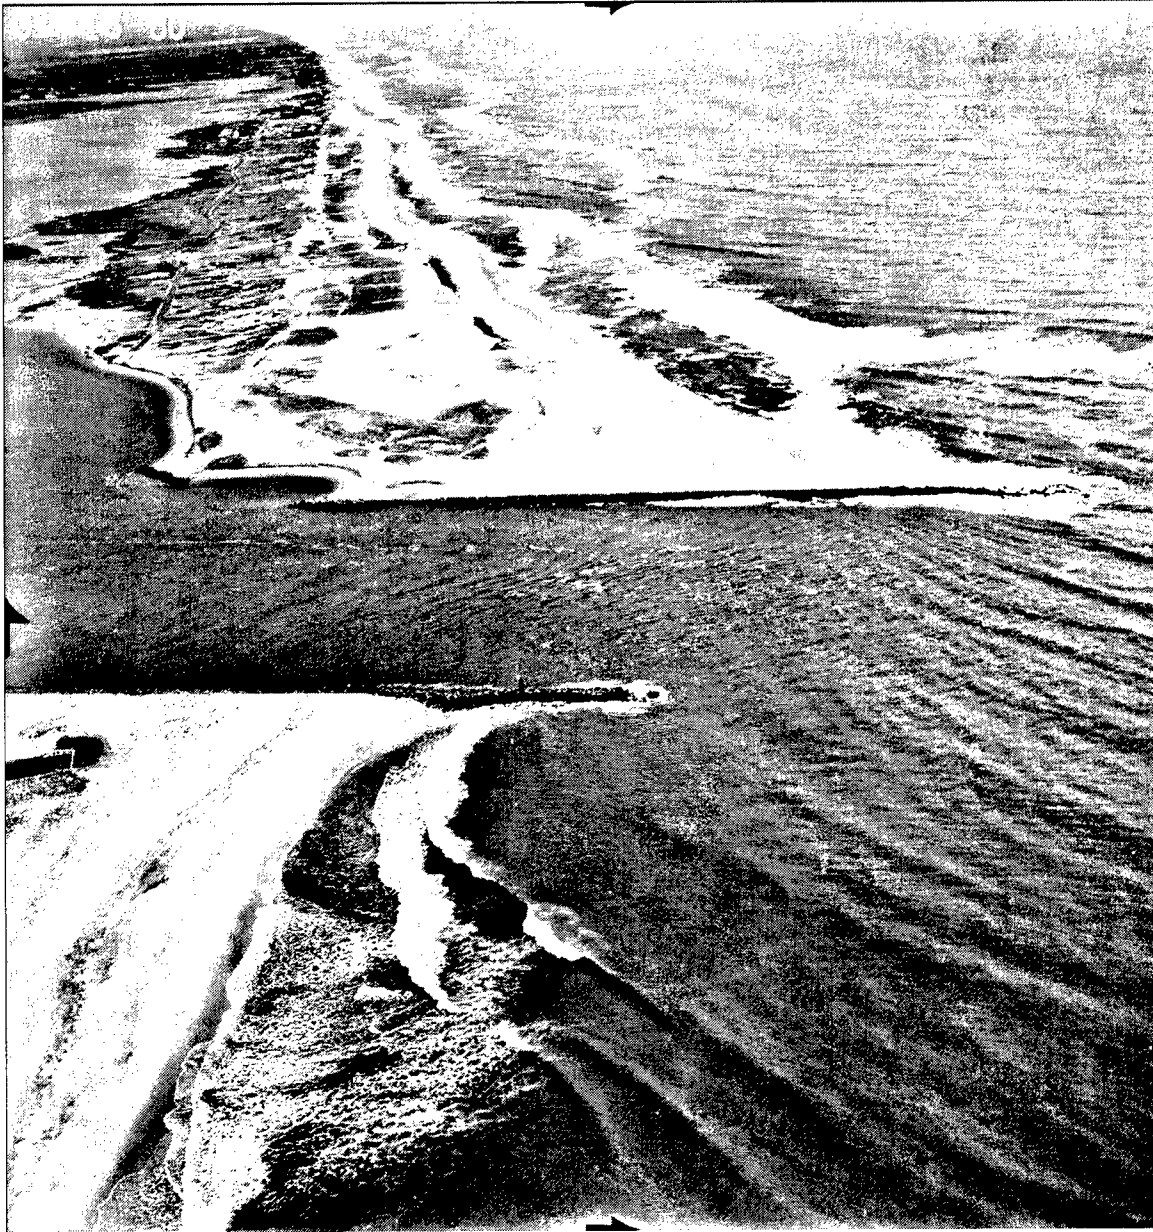
Figure 13. View east, with Atlantic Ocean to right, 18 January 1980 (Triangular-shaped updrift fillet is pronounced just beyond east jetty. Original, pre-inlet dune line approximately followed white line that marks dune crest in distance. Road paralleled dune crest and continued west before inlet was cut in 1938. Tip of west jetty has deteriorated. Remains of 1940 revetment are not visible in this image) (Topo-Metrics image 08013 0-16)

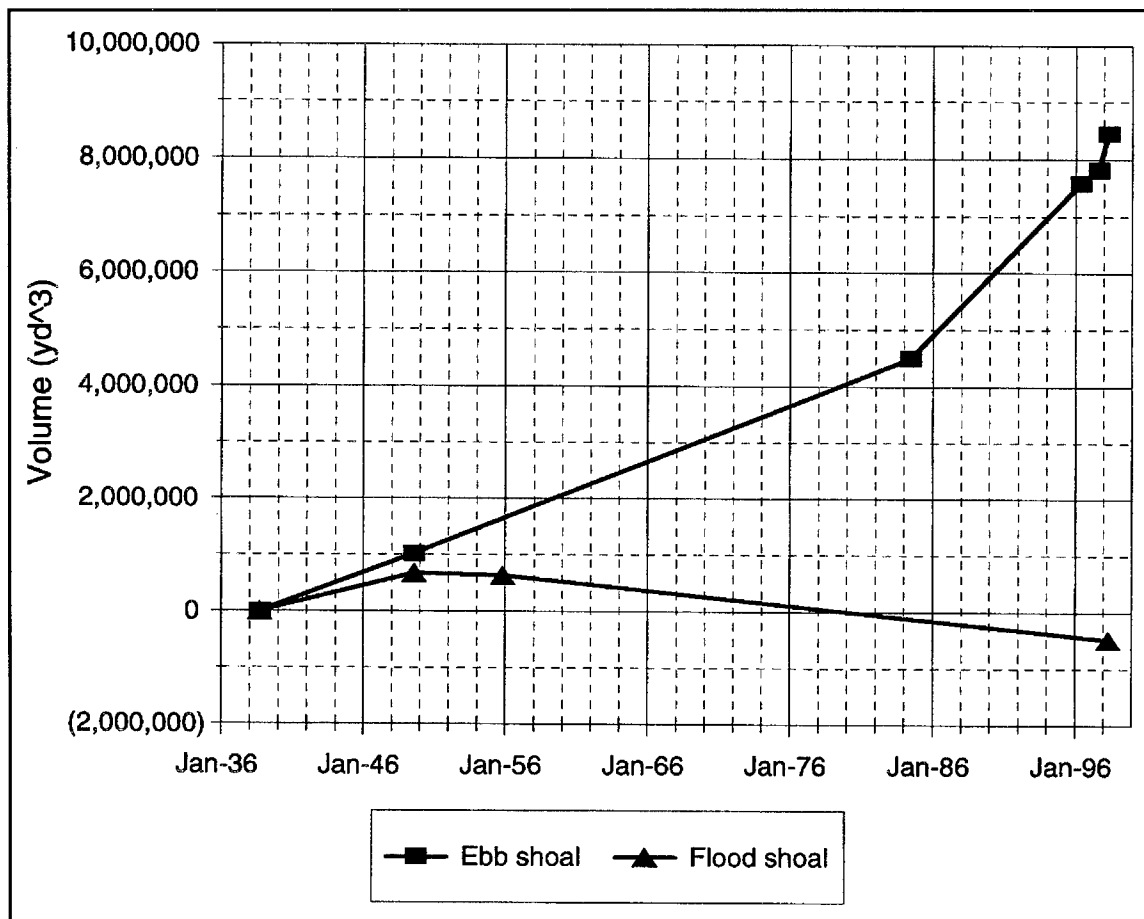
Figure 15. Volume changes, ebb and flood shoals (Although original survey data were collected in 1933, base condition (zero) is plotted at 21 September 1938, when inlet was cut by Great New England Hurricane)

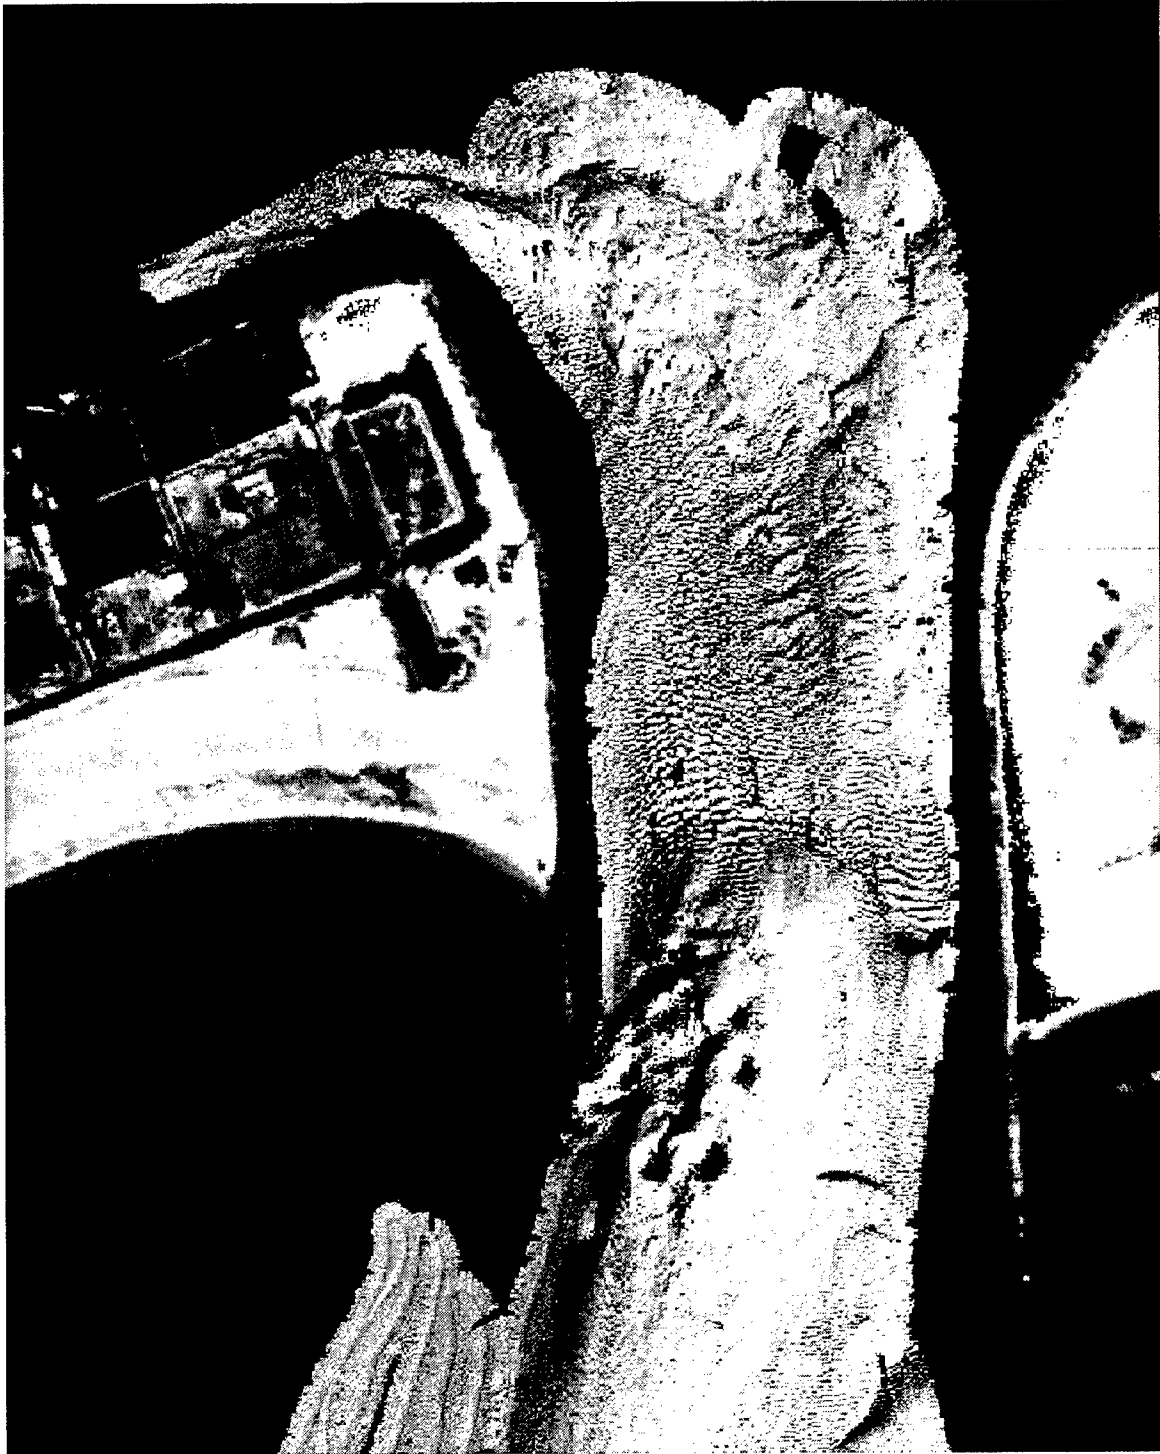
Figure 28. Multibeam acoustic data, 31 October 1998 (Sand waves are evident in inlet. Edge of sand ridge (discussed in text) is marked by line where the sand waves join featureless inlet floor. Highly irregular bottom near tip of west jetty indicates scour holes and remnants of scour blanket. Acoustic data processed at 1-m grid size, shaded with simulated sun position at 315° azimuth and elevation of 45°. Data collected and processed by Marine Sciences Research Center, State University of New York, Stony Brook, NY)

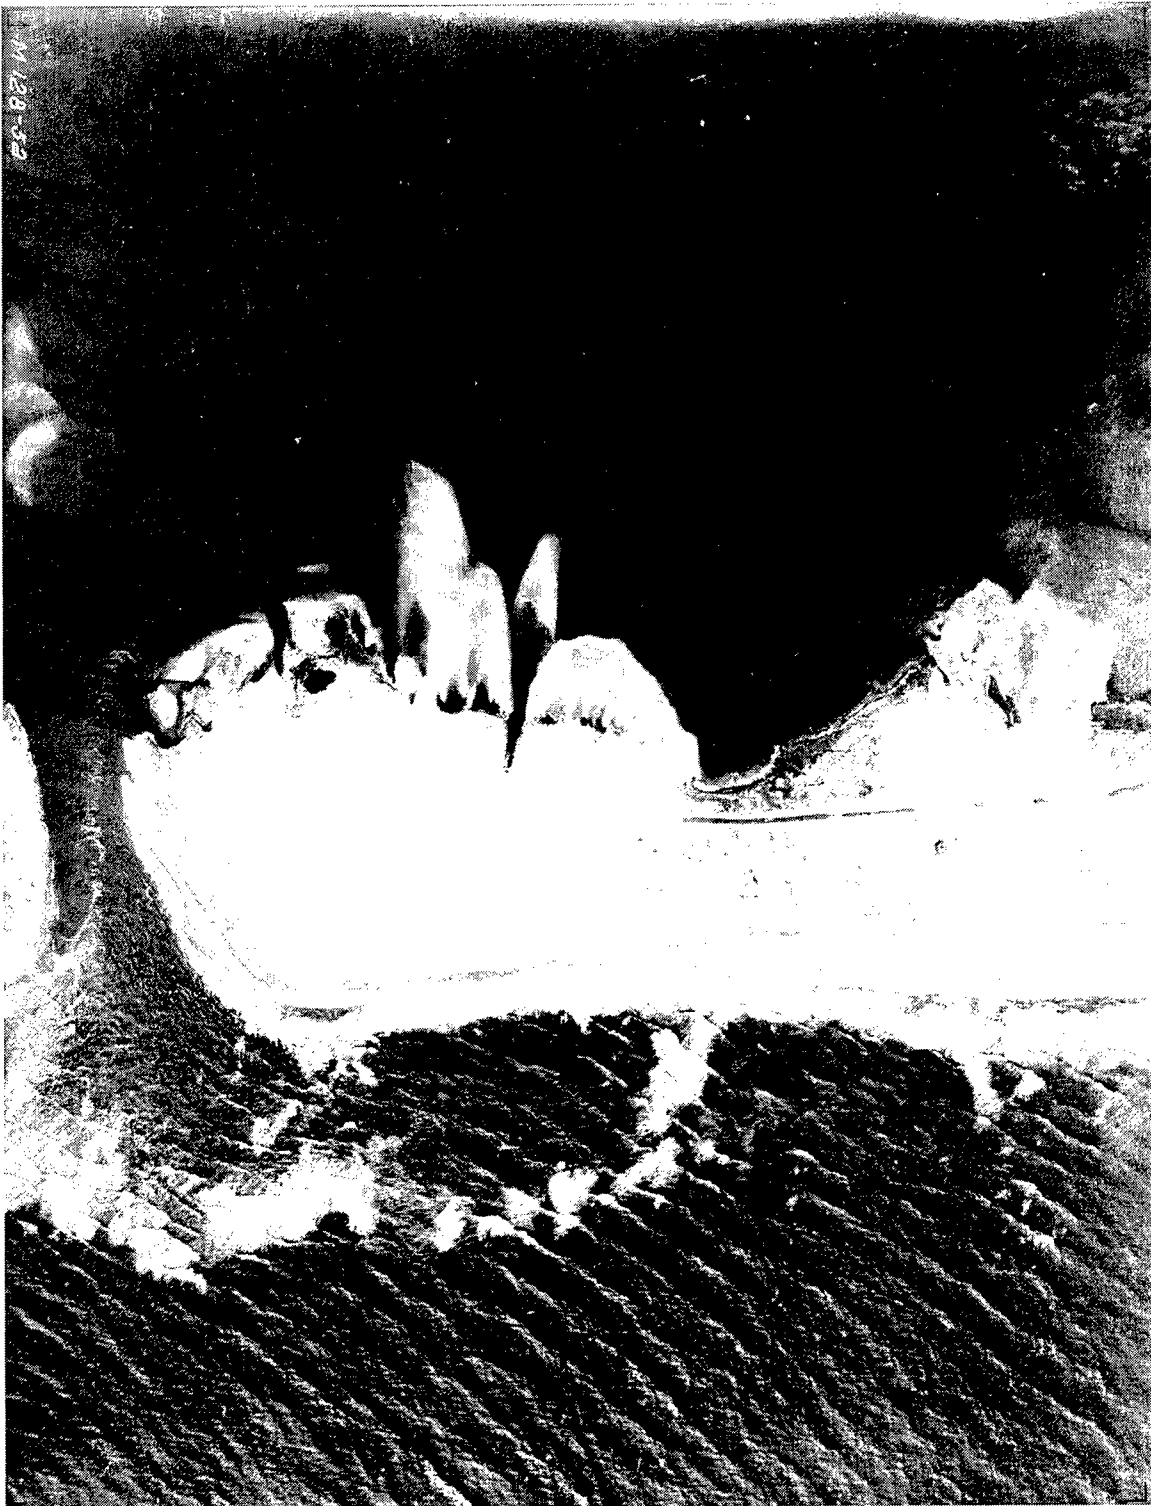
Figure A3. 29 November 1938 (Photograph one of three (east of inlet). Taken 1 month after the 21 September hurricane breached the barrier island. Washover deposits have covered most of the paved road. Breaking waves outline recently formed ebb shoal. Series of photographs taken by the Army Air Corps)

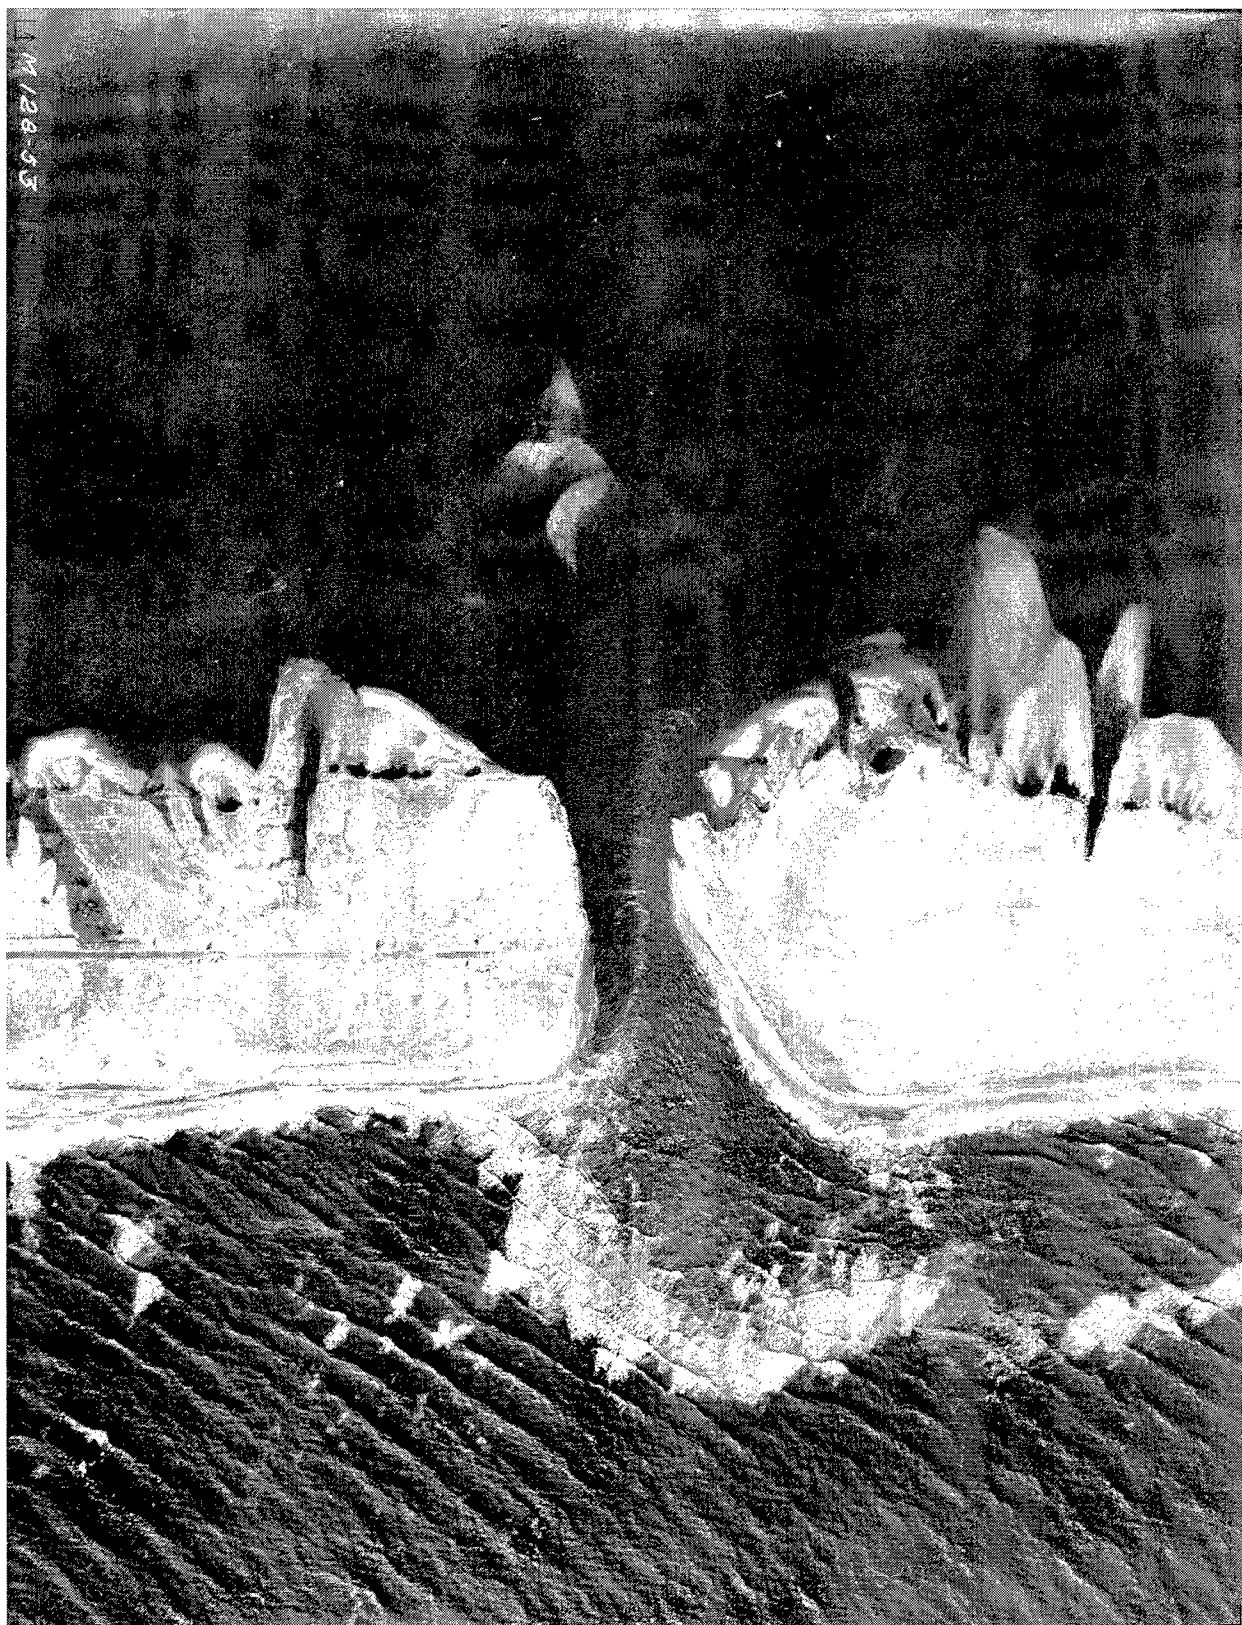
Figure A4. 29 November 1938 (Photograph two of three (centered on inlet). Ebb and flood shoals are already forming)

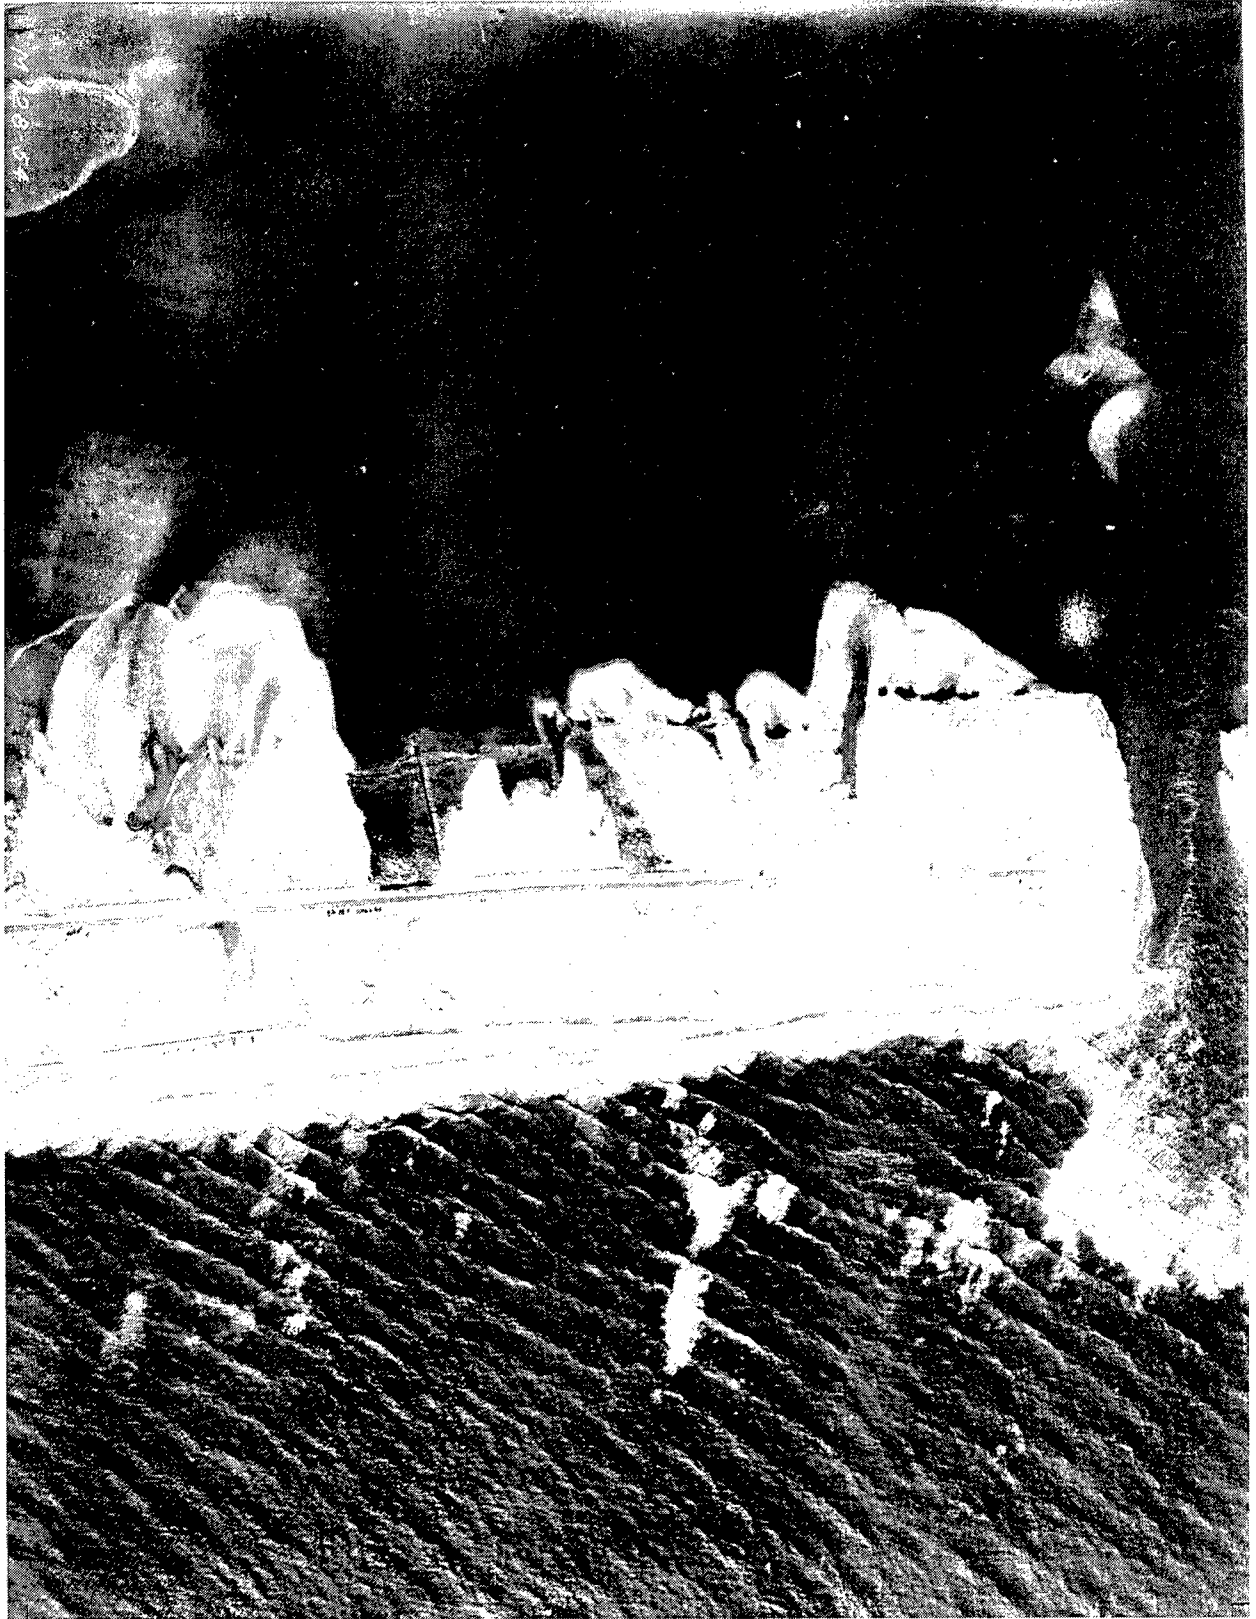
Figure A5. 29 November 1938 (Photograph three of three (west of inlet). Minor inlet, in the leftmost overwash fan, has closed (see Figure A2))

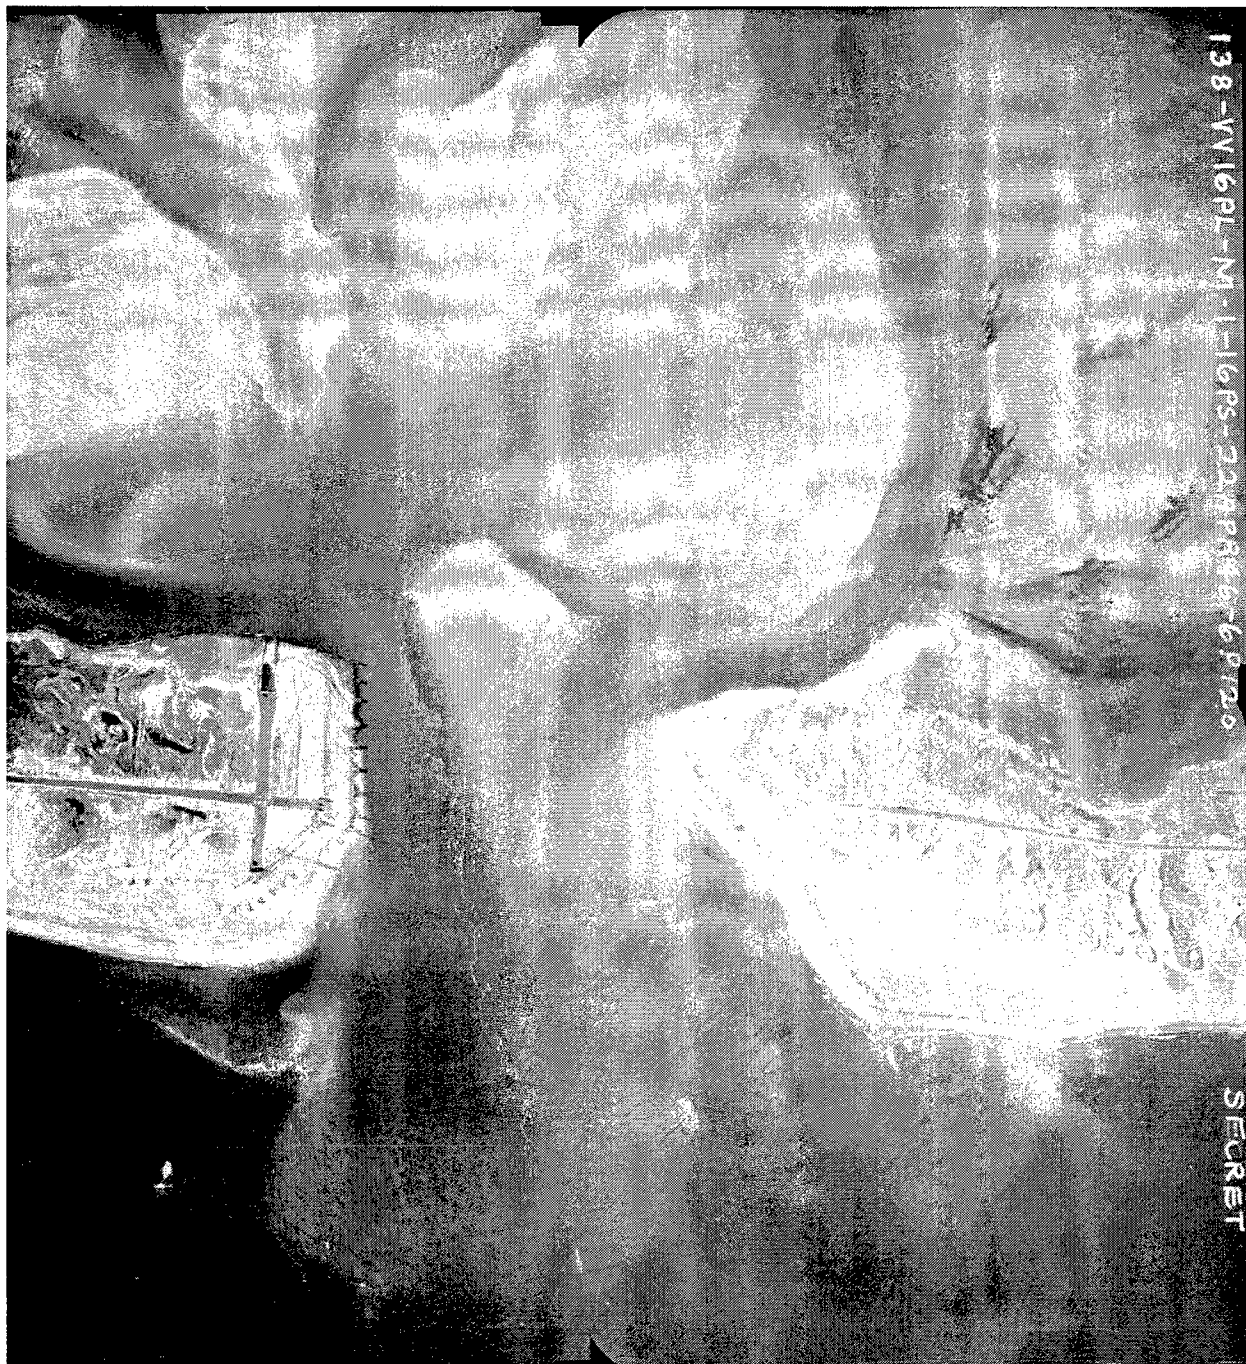
Figure A12. 22 April 1946 (Channel borders west side of inlet. Channel north of west beach connects to Long Island Intracoastal Waterway (dredged in 1943))

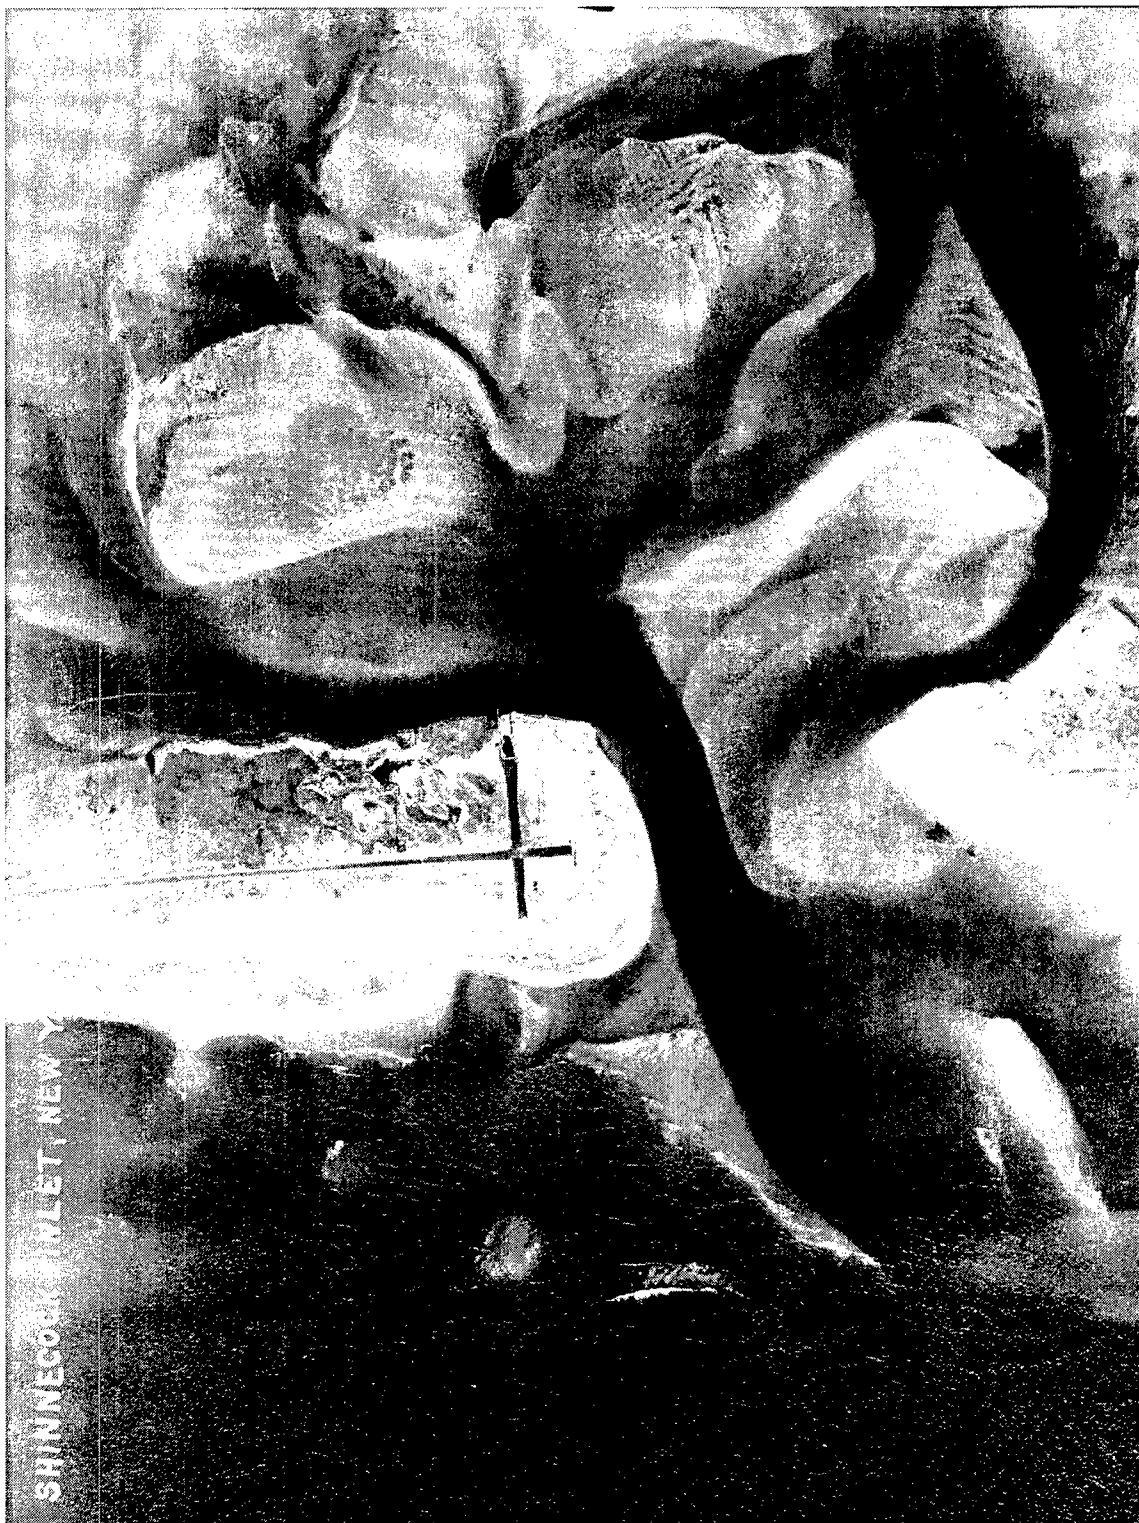
Figure A13. 1 April 1947 (Photograph one of two (inlet and west beach). Flood shoal has grown notably since 1941. Main channel through inlet has migrated away from west shore revetment and extends out to sea in a NW-SE direction. On flood shoal, east channel has shoaled next to east shoreline of inlet. Main channel now turns west and follows bay shoreline of west beach)

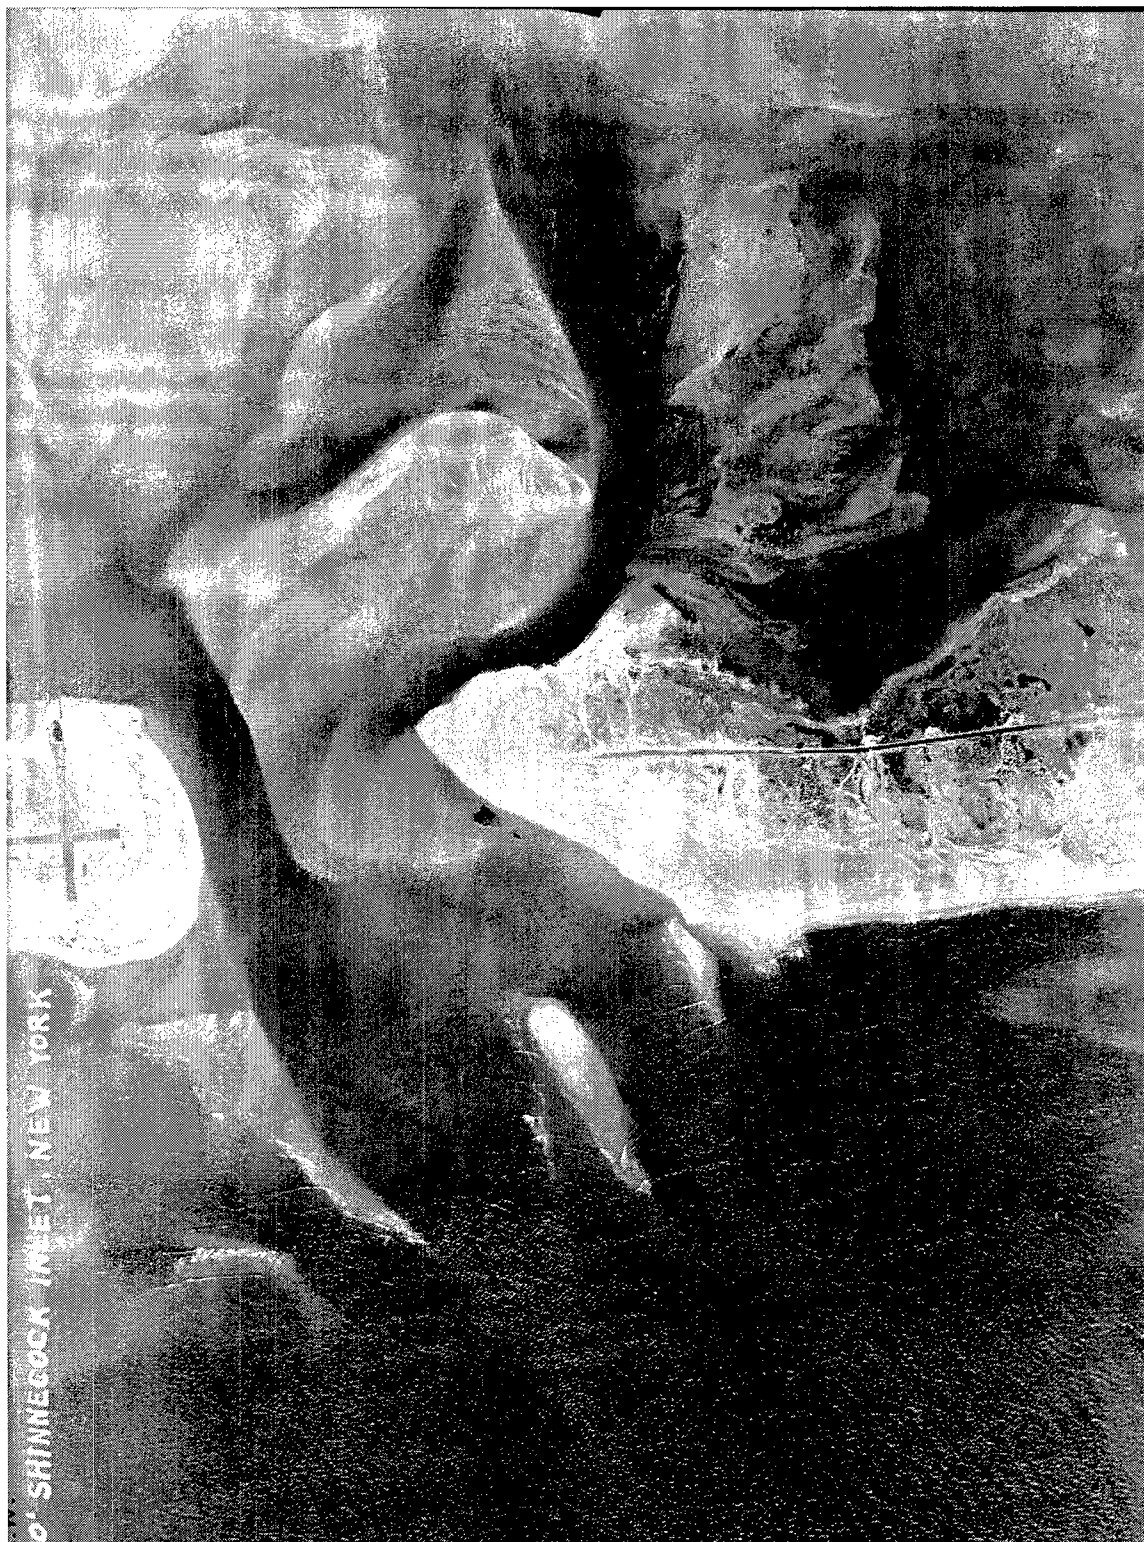
Figure A14. 1 April 1947 (Photograph two of two (inlet and east beach). Inlet's mouth contains two exposed sand shoals, and a spit has emerged from the west beach. Predominant longshore drift appears to have been west to east for a period before image was taken)

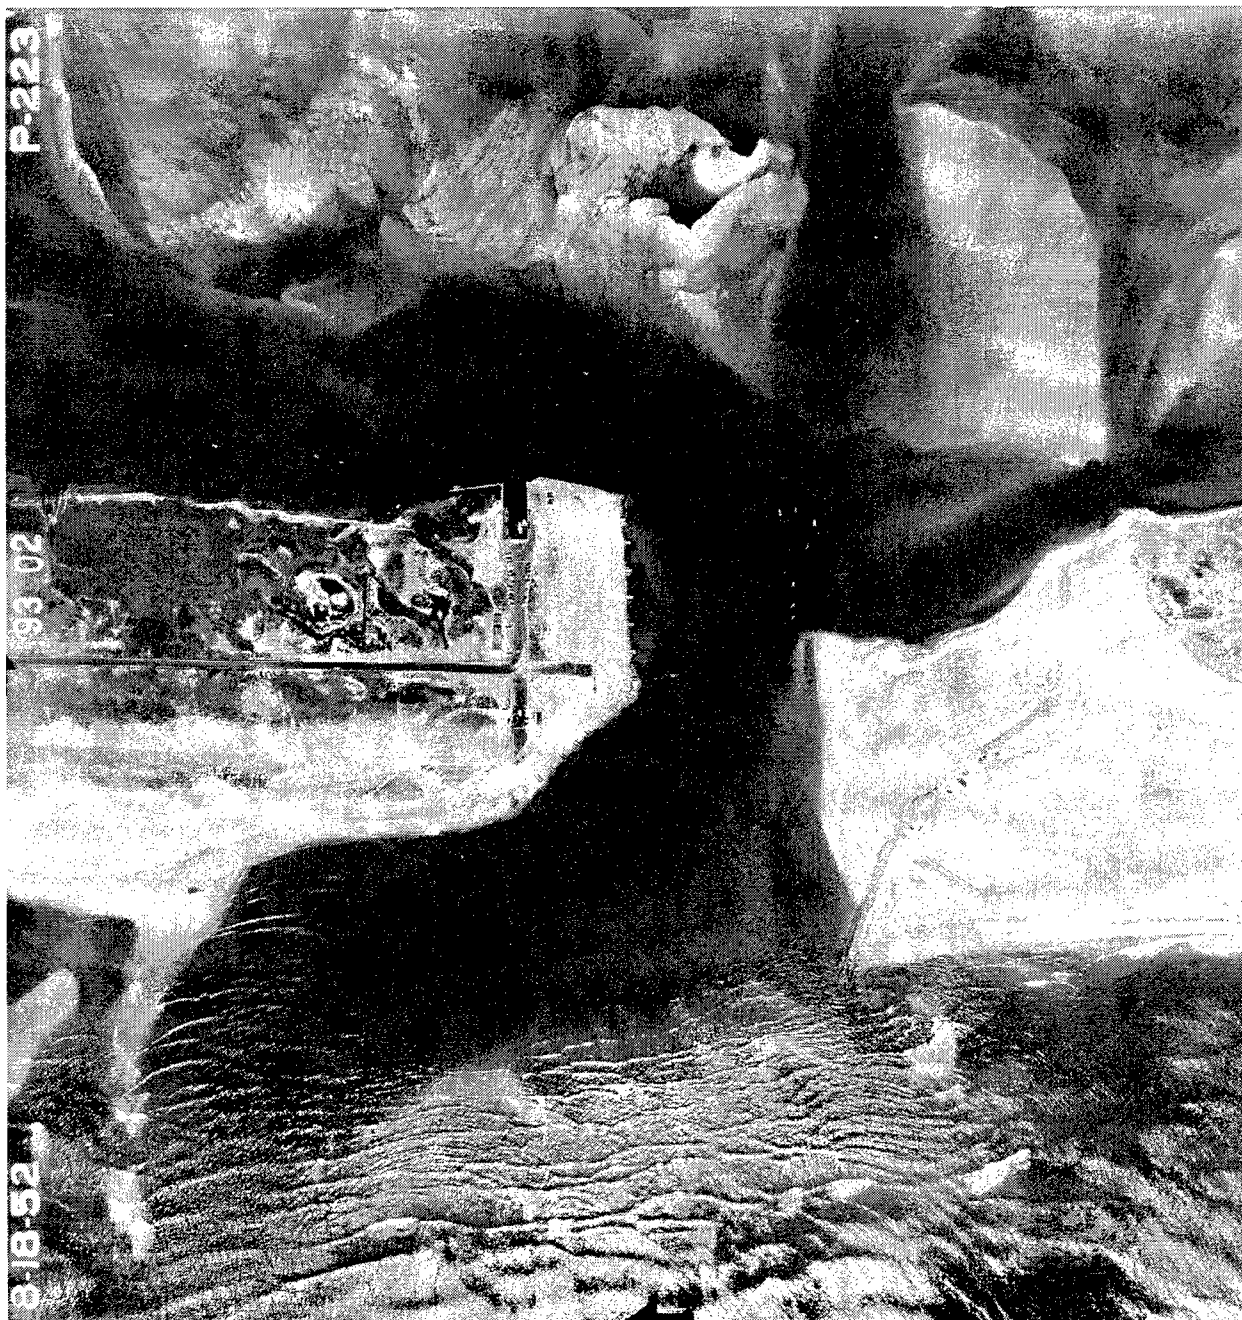
Figure A16. 18 August 1952 (Construction of east jetty is underway. North side of east beach has scoured, and a spit extends out to Atlantic from the west beach. This suggests that the main tidal currents ran approximately northeast-southwest)

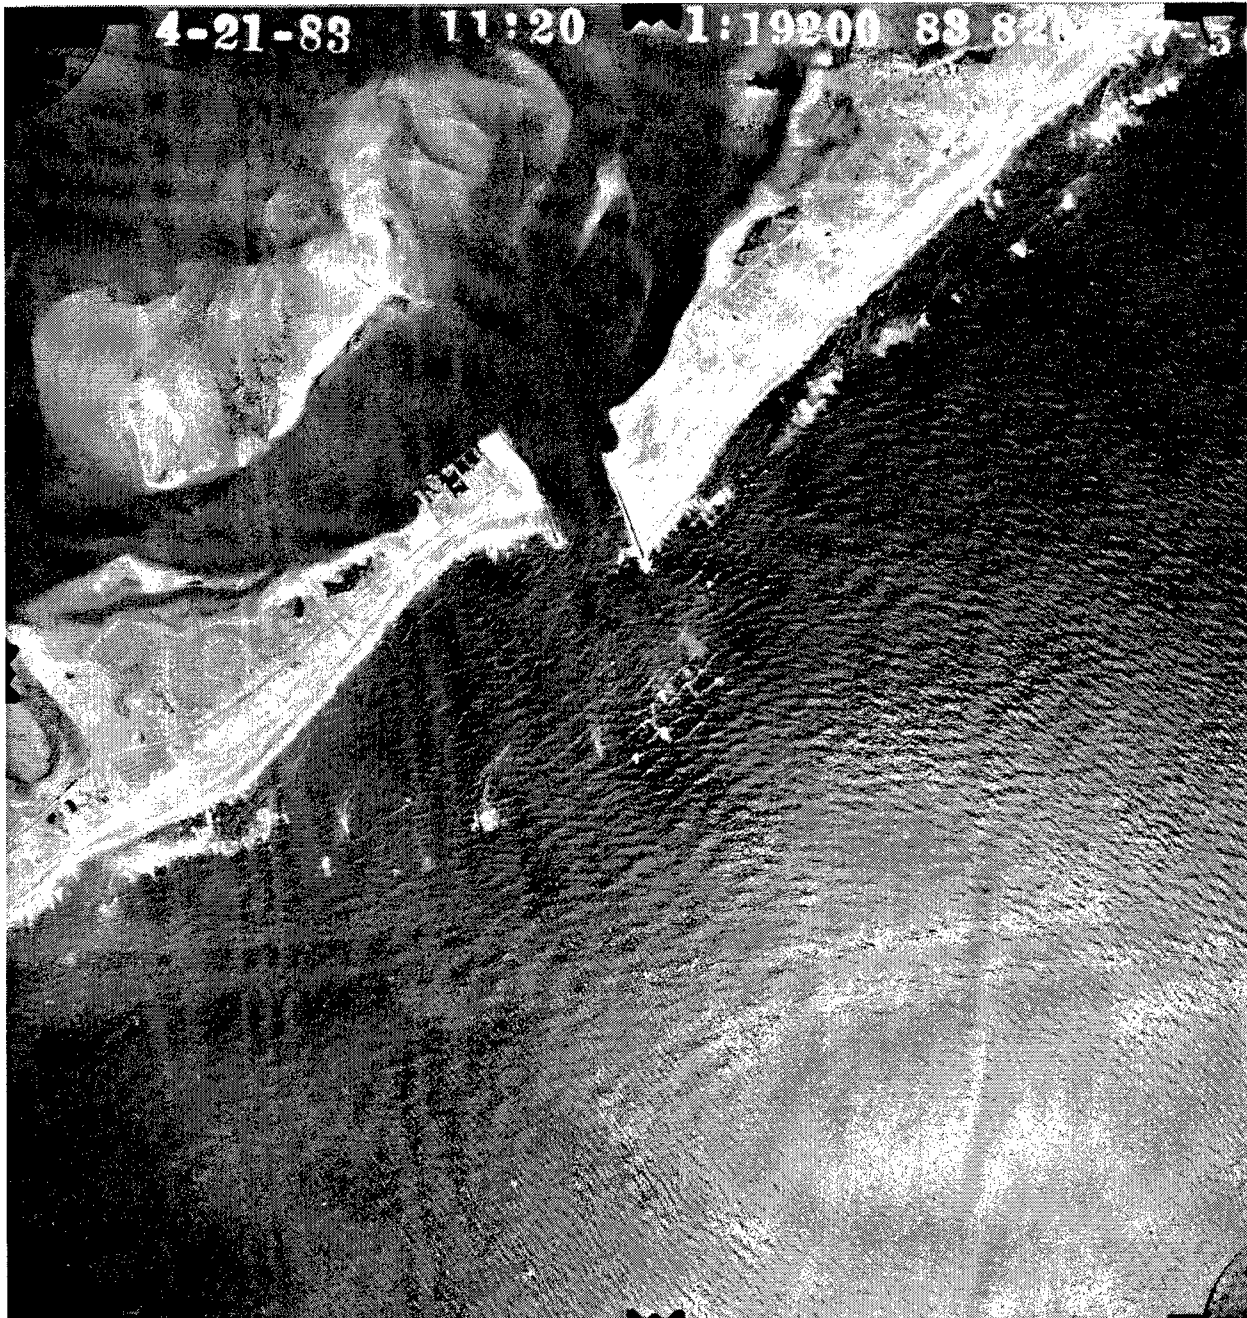
Figure A28. 21 April 1983 (Oval ebb shoal is outlined by breaking waves. The shoal attaches to downdrift (west) beach at the bulge in the shoreline. Bulge has moved about 500 m west compared with 1976)

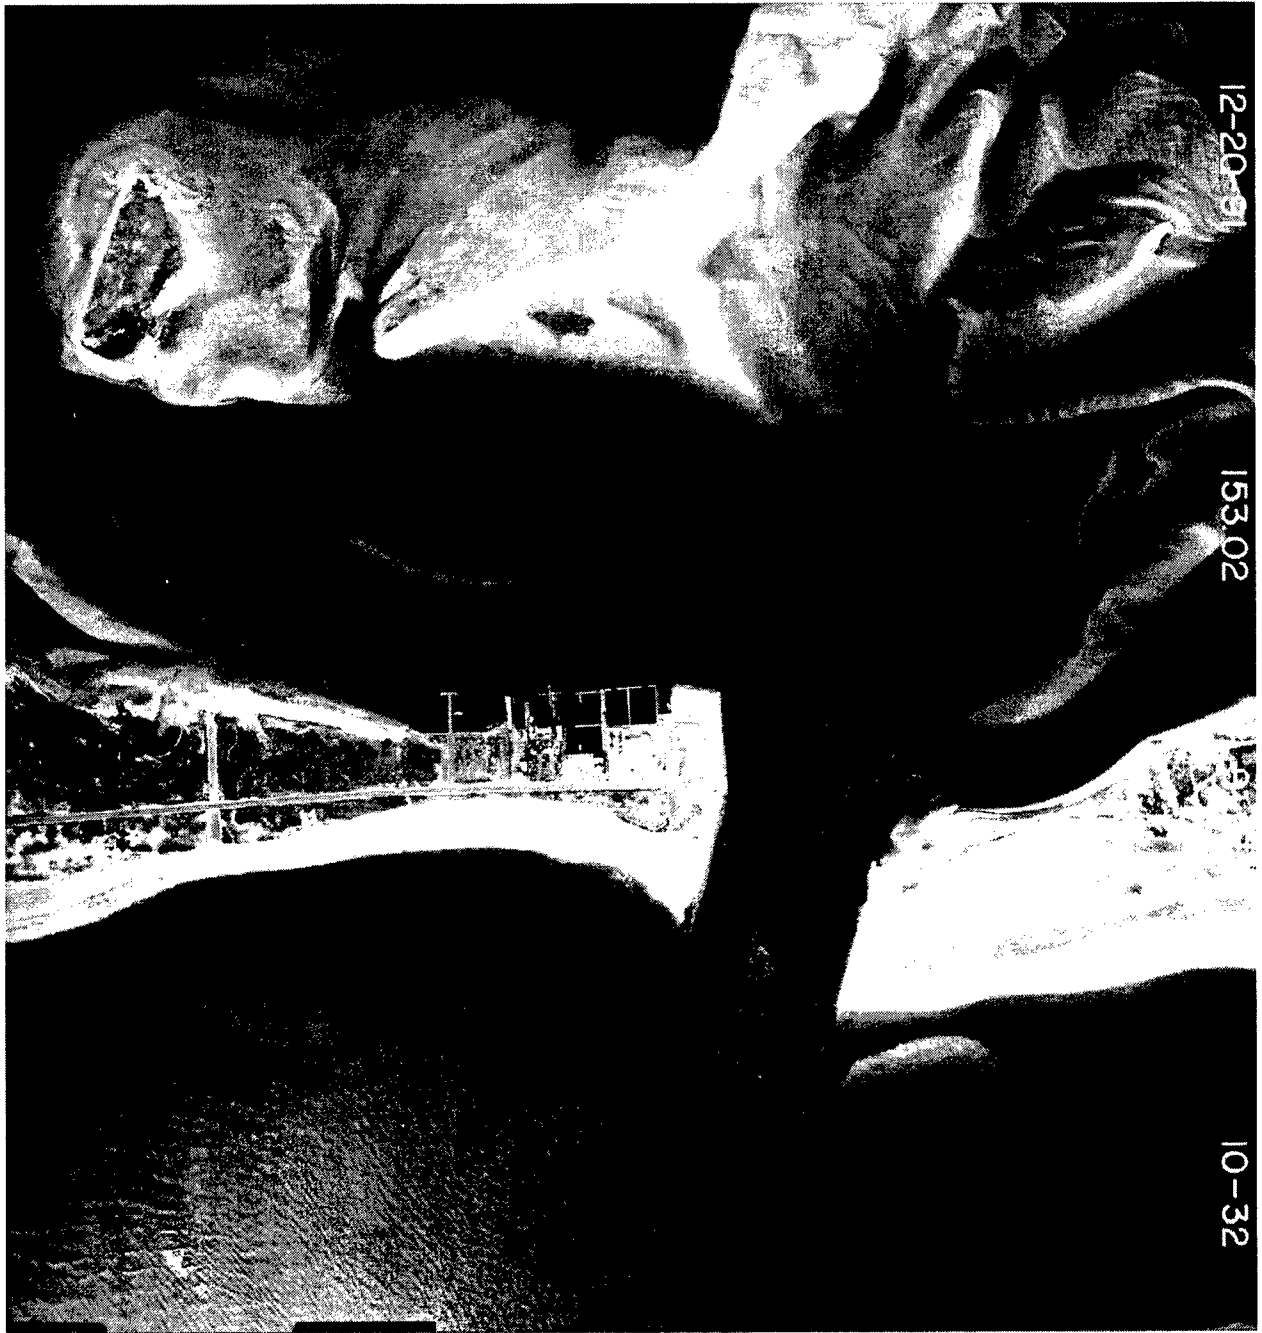
Figure A35. 20 December 1991 (Most features are unchanged from the previous figure, taken in September. Lack of change is surprising because the Halloween Northeaster of 30-31 October was reported to have caused erosion and damage along much of Long Island shore. Erosion pocket in east revetment has shoaled, and west beach has advanced about one-half of the distance to the jetty tip)
